Department of Water Resources

BULLETIN No. 136

NORTH COASTAL AREA INVESTIGATION

ENGINEERING GEOLOGY

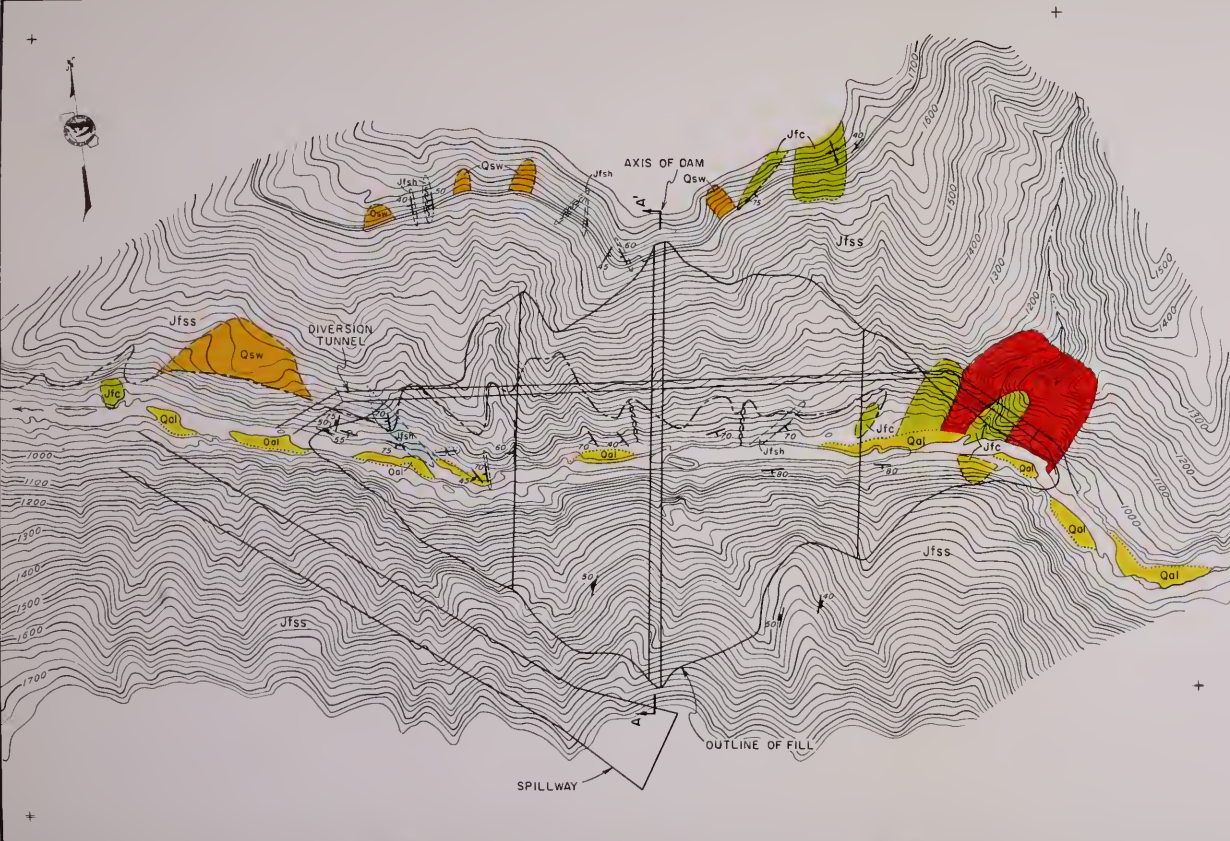
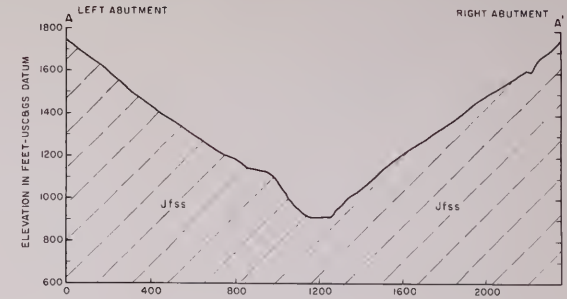
GEOLOGIC MAP AND SECTION DOS RIOS DAMSITE - M FK EEL RIVER

STATE OF CALIFORNIA
THE RESOURCES AGENCY
DEPARTMENT OF WATER RESOURCES
NORTHERN BRANCH
NORTH COASTAL AREA INVESTIGATION
GEOLOGIC MAP AND SECTION
OOS RIOS DAMSITE-M FK EEL RIVER

SCALE OF FEET
0 400
Contour Interval 20'

The engineering geology of possible projects on the Middle Fork Eel River is discussed in this chapter. The projects, shown on Plate 1, include Dos Rios Dam and Reservoir, Spencer Dam and Reservoir, Franciscan Dam, and the Eel-Glenn and Elk Creek Tunnels. Geologic maps, cross sections, and location of construction materials for these projects are shown on Plates 3 through 8.

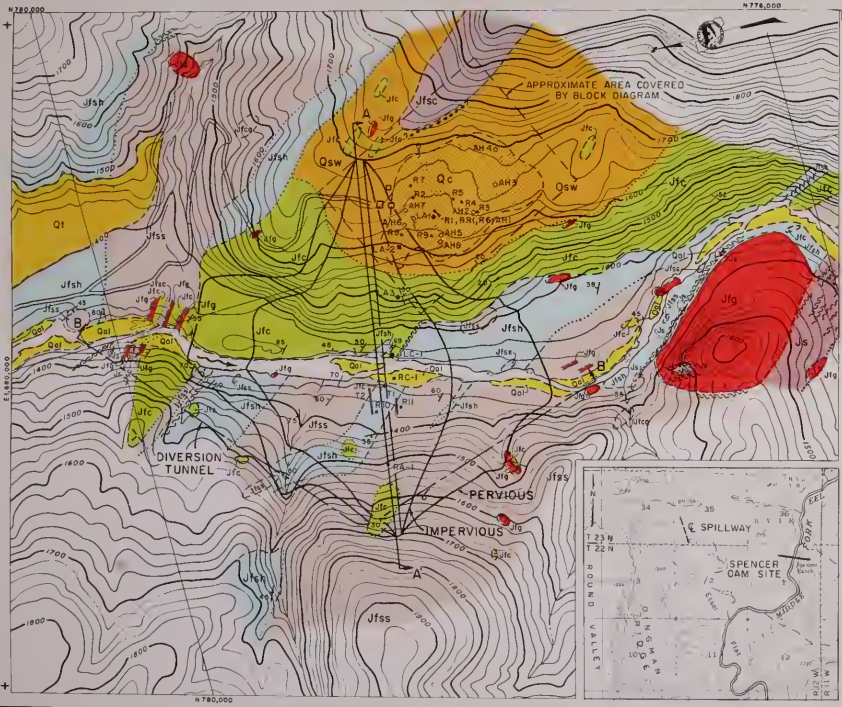
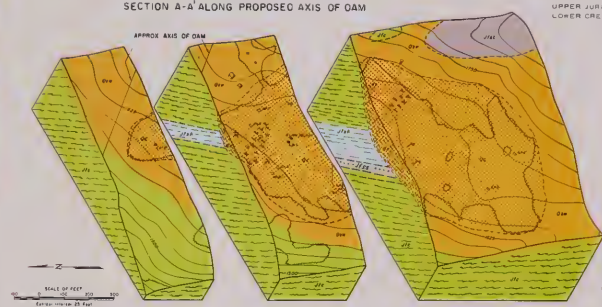
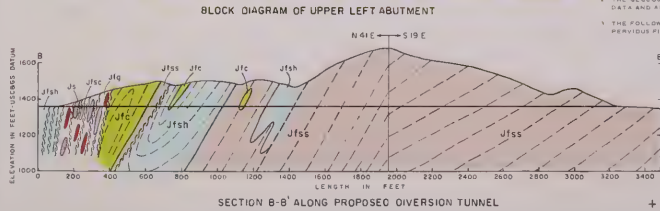
STATE OF CALIFORNIA
THE RESOURCES AGENCY
DEPARTMENT OF WATER RESOURCES
NORTHERN BRANCH
NORTH COASTAL AREA INVESTIGATION
GEOLOGIC MAP AND SECTIONS
SPENCER DAM SITE - M FK EEL RIVER
SCALE OF FEET
0 400
Contour Interval 20

- LEGEND**
- QUATERNARY UNCONSOLIDATED DEPOSITS**
- Qal RECENT ALLUVIUM - CONSISTING OF CHANNEL SAND AND GRAVEL BARS.
 - Qsw RECENT SLOPE WASH - CONSISTING OF FINE-GRAINED SOILS GENERALLY UNDERLAIN BY CHERT AND SHALEY CHERT.

- Qc CLAY - LOW STRENGTH, CONTAINS BLOCKS AND FRAGMENTS OF HARD ROCK.
 - Ql RECENT TERRACE DEPOSIT - GRAVEL, SAND AND SILT.
- QUATERNARY**
- FRANCISCAN GROUP**

3. THE FOLLOWING EMBANKMENT SLOPES WERE USED: IMPERVIOUS FILL UPSTREAM - 2:1, DOWNSTREAM - 1:1; PERVIOUS FILL UPSTREAM - 3:1, DOWNSTREAM - 2:1.

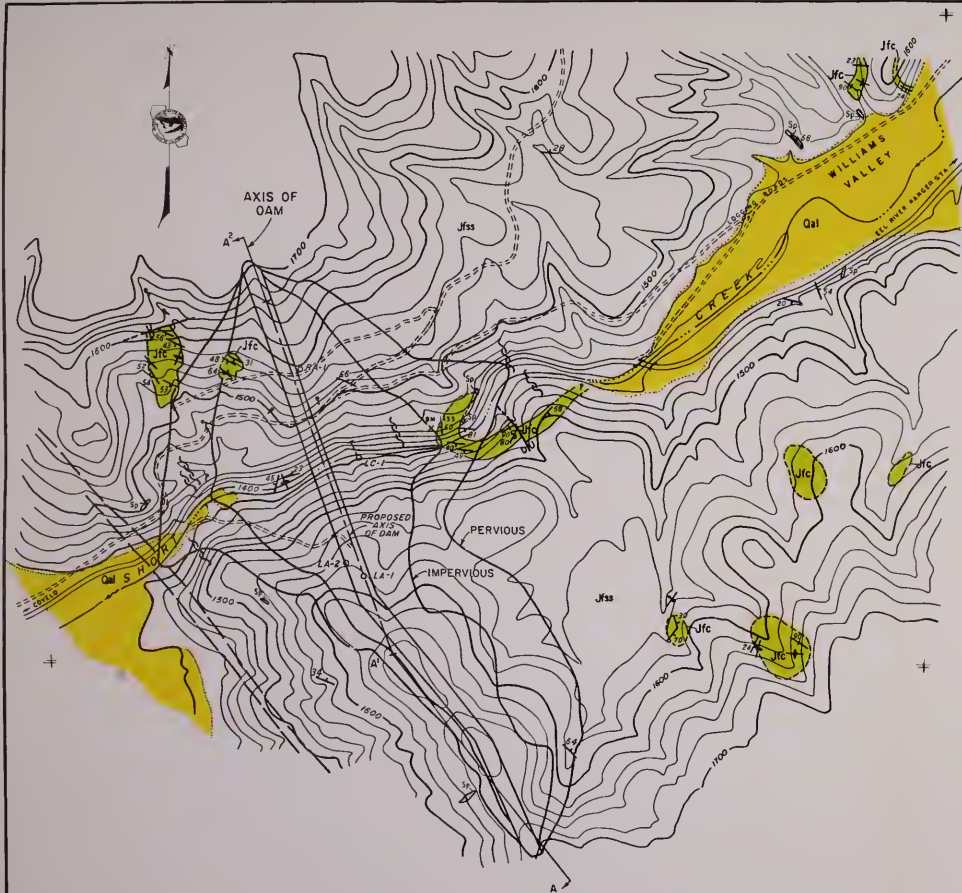
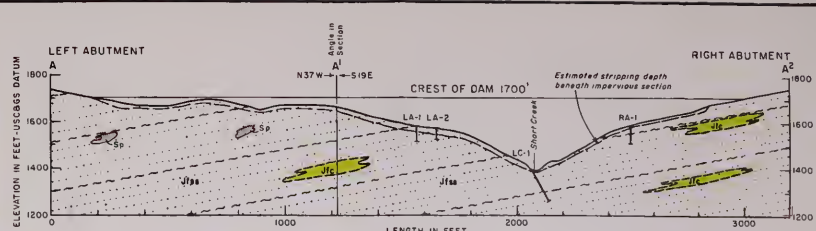
STATE OF CALIFORNIA
THE RESOURCES AGENCY
DEPARTMENT OF WATER RESOURCES
NORTHERN BRANCH
NORTH COASTAL AREA INVESTIGATION
GEOLOGIC MAP AND SECTION
FRANCISCAN DAMSITE - SHORT CREEK

- LEGEND**
- QUATERNARY**
- Qal** ALLUVIUM
UNCONSOLIDATED STREAM DEPOSIT AND VALLEY FILL
 - Jfss** FRANCISCAN SANDSTONE
QUARTZ LITHIC GRAYWACKE, MASSIVE, WELL INDURATED, MODERATELY FRACTURED, CONTAIN BEDS TOO THIN TO MAP OF BLACK SLATY-SHALE.
 - Jfc** FRANCISCAN-CHERT
WELL BEDDED, SOMEWHAT CONTORTED
 - Sp** FRANCISCAN SERPENTINE
DARK GREEN, OFTEN TALCOSE, SHEARED; OFTEN SURROUNDED BY HYDROTHERMALLY ALTERED ZONES.

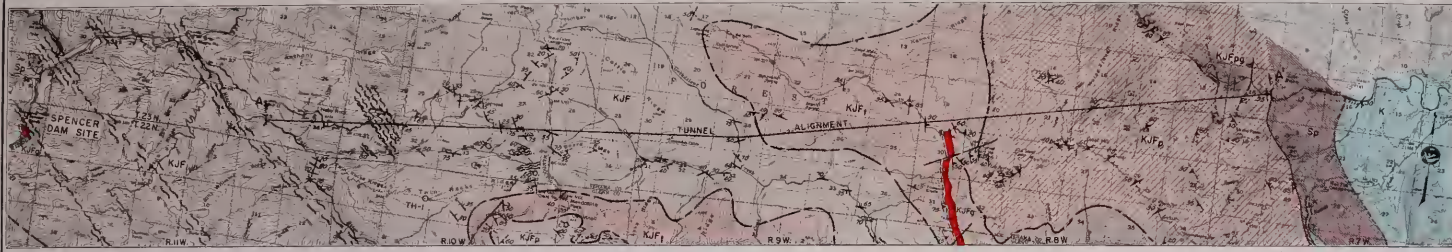
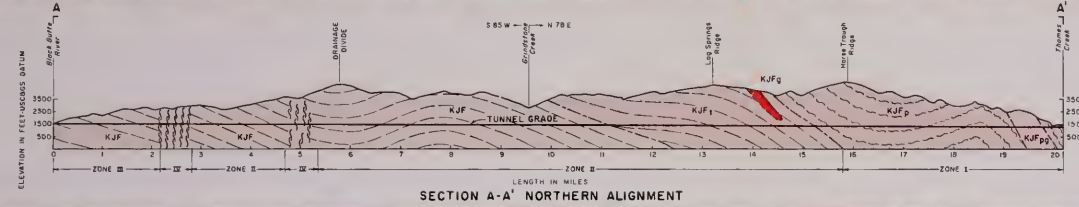
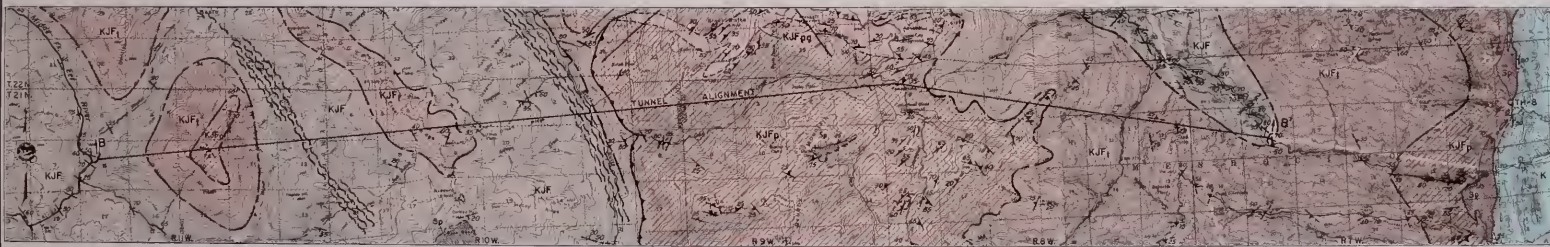
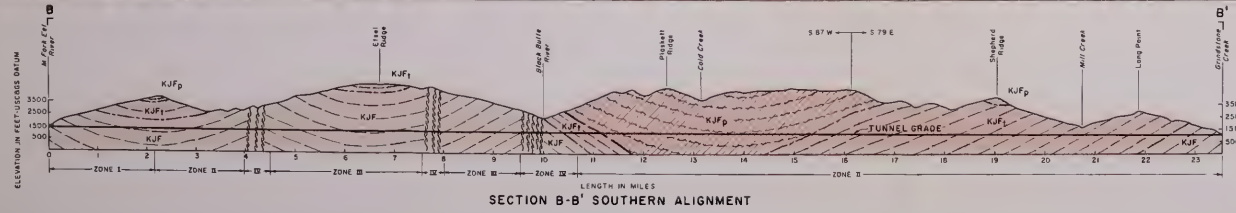
STATE OF CALIFORNIA
THE RESOURCES AGENCY
DEPARTMENT OF WATER RESOURCES
NORTHERN BRANCH
NORTH COASTAL AREA INVESTIGATION
**GEOLOGIC MAP AND SECTIONS
EEL-GLINN TUNNEL**
SCALE OF MILES
0 1 2

- LEGEND**
- KJf** FRANCISCAN - PREDOMINANTLY SHALE AND SANDSTONE. ALL UNITS HAVE SUFFERED CONSIDERABLE WEARING AND ARE EXTENSIVELY FOLDED AND FAULTED. LESS IMPORTANT UNITS INCLUDE CONGLOMERATE, GREENSTONE, CHERT AND LIMESTONE.

- KJf1** TRANSITIONAL FRANCISCAN - SLIGHTLY METAMORPHOSED EQUIVALENTS OF KJf. SLATE AND SLATTY SHALE ALONG WITH PHYLLITE AND SLATTY GREENSTONE SANDSTONE ARE THE MOST PROMINENT UNITS. GREENSTONE, CHERT AND CONGLOMERATE FORM THE REMAINDER OF THIS GROUP OF ROCKS.

The Eel-Glenn Tunnels are designed to convey the surplus flows of the Middle Eel River into the Glenn Reservoir Complex (see Plate 1). These tunnels would be at least 10 feet in diameter and in excess of 20 miles in length, and have a capacity of about 1,000 second-feet.

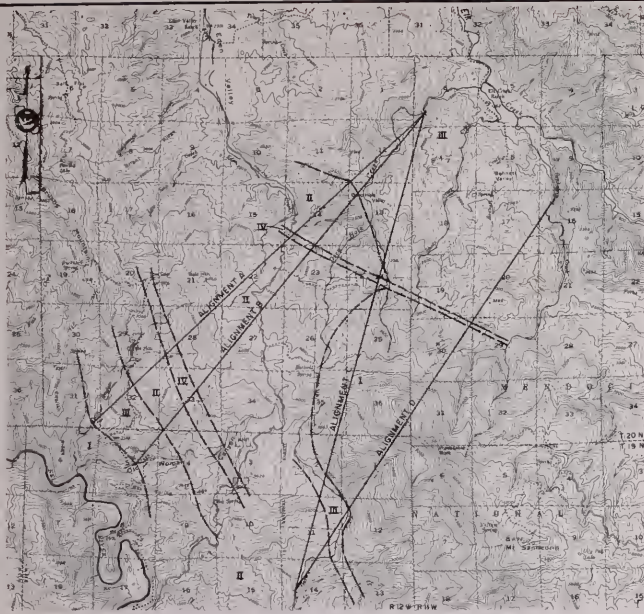
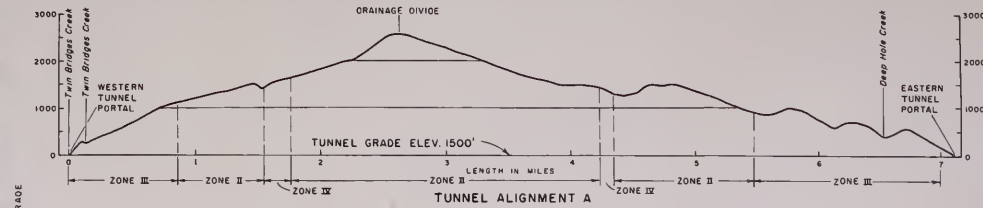
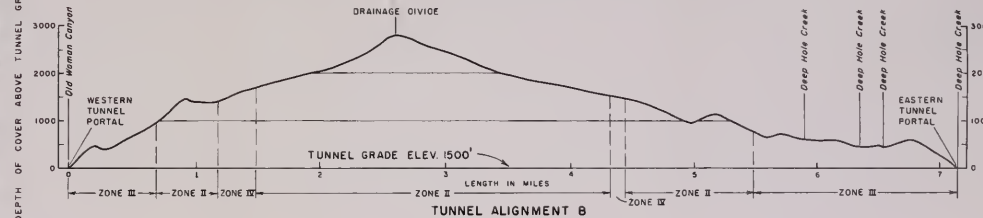
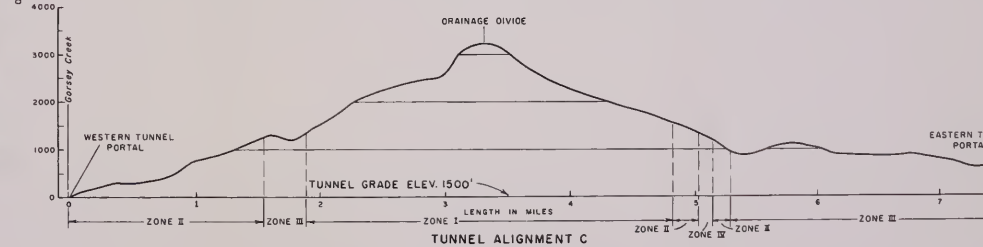
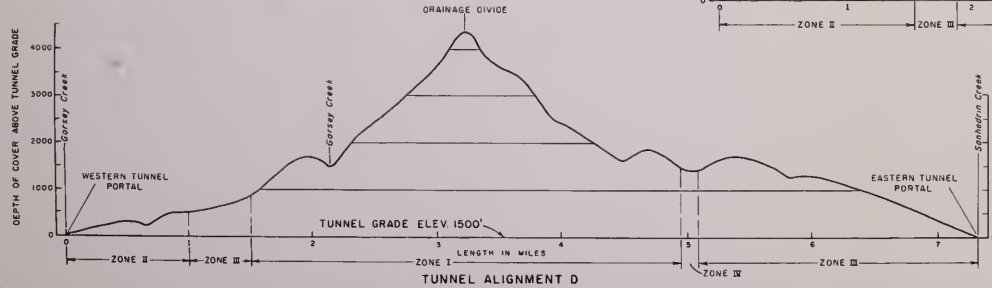
TUNNELING CONDITIONS MAP AND SECTIONS ELK CREEK TUNNEL

ZONE I: SEDIMENTARY ROCK UNITS OF THE CENTRAL BELT FRANCISCAN WHICH ARE ONLY MODERATELY SHEARED & JOINTED.

ROCK CONDITION	ROCK LOAD IN HP IN FEET	PERCENT OF ZONE
MODERATELY "SLACKY" AND VERY "SLACKY" AND SLANT	0.34(18+HP)	75
VERY "SLACKY" AND SLANT	0.72(18+HP)	25

ABOUT 15% OF THIS ZONE WILL BE EXCAVATED UNDER "NET HEADING" CONDITIONS.

ZONE II: ZONE II IS SIMILAR GEOLOGICALLY TO ZONE I BUT HAS A HIGHER SHALE/LIMESTONE RATIO AND MORE CONSIDERABLY MORE SHEARING AND FRACTURING.

ROCK CONDITION	ROCK LOAD IN HP IN FEET	PERCENT OF ZONE
VERY "SLACKY" AND SLANT	0.72(18+HP)	50
COMPLETELY CRUSHED	1.10(18+HP)	10

ZONE III: SHEARED AND FRACTURED FRANCISCAN ROCK, INTERRUPTED BY CRUSHED SERPENTINE AND CUT BY NUMEROUS FAULTS.

ROCK CONDITION	ROCK LOAD IN HP IN FEET	PERCENT OF ZONE
VERY "SLACKY" AND SLANT	0.72(18+HP)	50
COMPLETELY CRUSHED	1.10(18+HP)	50

ZONE IV: COMPLETELY CRUSHED ODOGY FAULT ZONE MATERIAL. "SLACKY" CONDITIONS AND "RUNNING GROUND" SHOULD BE ANTICIPATED.

ROCK CONDITION	ROCK LOAD IN HP IN FEET	PERCENT OF ZONE
COMPLETELY CRUSHED	1.10(18+HP)	75
MODERATELY CRUSHED ROCK	2.10(18+HP)	25

50% OF ZONE IV IS EXPECTED TO BE "NET HEADING" TUNNELING.

- TUNNELING CONDITIONS ZONES**
(SHOWN ON GEOLOGIC SECTIONS)
- ZONE I** INCLUDES ROCKS OF THE PLASKETT UNIT AND ESPECIALLY COMPETENT PORTIONS OF THE FRANCISCAN AND TRANSITIONAL FRANCISCAN UNITS. THE ROCK IS SCHISTOSE OR STRATIFIED AND IS MODERATELY BLOCKY AND SEAMY.
 - ZONE II** INCLUDES ROCKS OF THE TRANSITIONAL FRANCISCAN UNIT AND LARGE PORTIONS OF THE FRANCISCAN. THE ROCK IS STRATIFIED TO SLATTY, MODERATELY TO INTENSELY FRACTURED.
 - ZONE III** INCLUDES PORTIONS OF FRANCISCAN WHERE THE SHALE SANDSTONE RAT IS HIGH AND WHERE CONSIDERABLE SHEARING WAS OBSERVED. THE ROCK IS INTENSELY FRACTURED TO COMPLETELY CRUSHED.
 - ZONE IV** INCLUDES SHEAR OF FAULT ZONES AND SERPENTINE. THE ROCK IS INTENSELY SHEARED AND BRICKIATED AND IS EXPECTED TO BE MODERATELY SQUEEZING AT DEPTH.

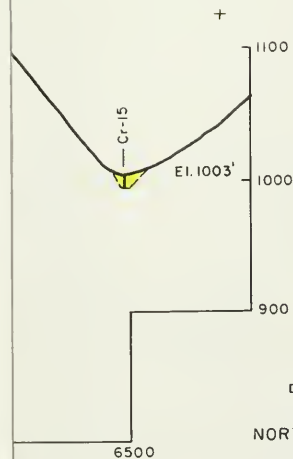
STATE OF CALIFORNIA
 THE RESOURCES AGENCY
 DEPARTMENT OF WATER RESOURCES
 NORTHERN BRANCH
 NORTH COASTAL AREA INVESTIGATION
 GEOLOGIC MAP, SECTION & LOGS
 CHROME DIKESITE
 GLENN RESERVOIR COMPLEX

Note: Geologic map-based on U.S. Dept.
 of Agriculture Aerial Photo

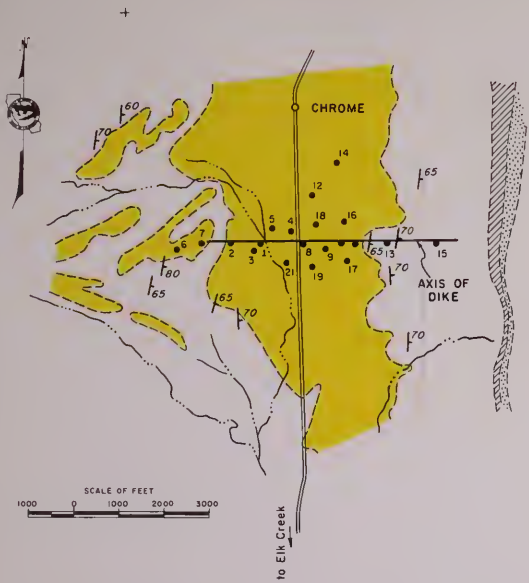
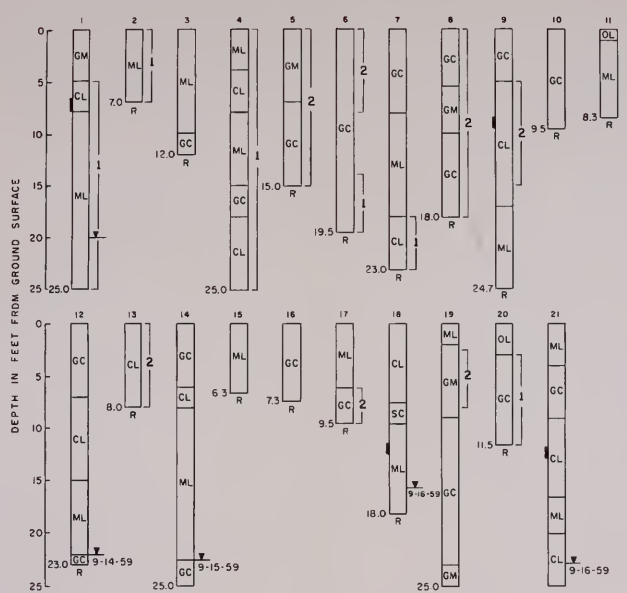
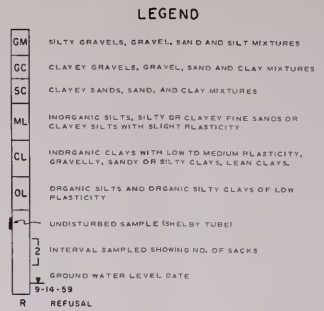
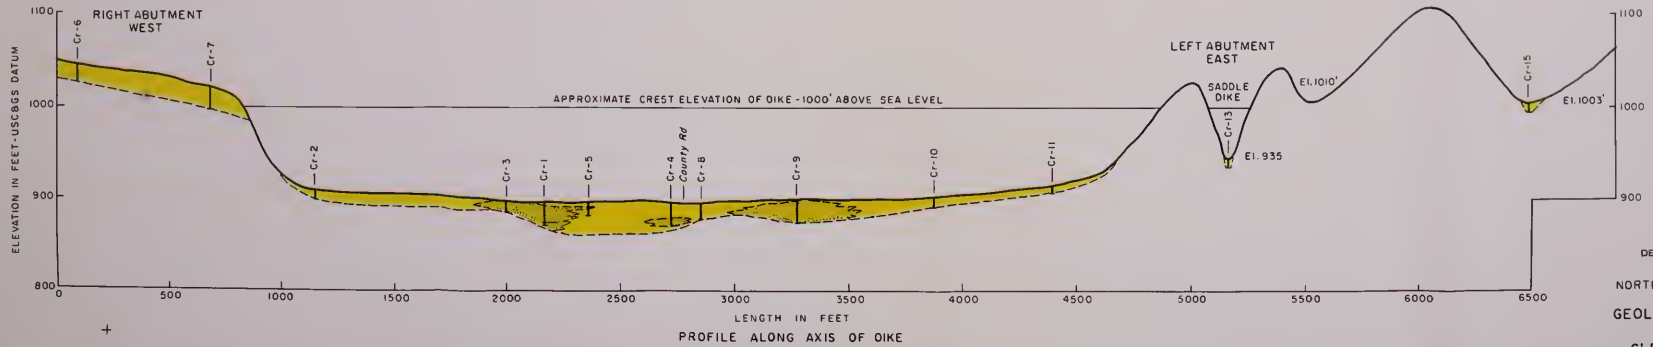
STATE OF CALIFORNIA
THE RESOURCES AGENCY
DEPARTMENT OF WATER RESOURCES
NORTHERN BRANCH
NORTH COASTAL AREA INVESTIGATION
GEOLOGIC MAP, SECTION 8 LOGS
CHROME DIKESITE
GLENN RESERVOIR COMPLEX

Note: Classification is based on field data. Symbols are unified soil classification system.

Note: Geologic map based on U.S. Dept. of Agriculture Aerial Photo

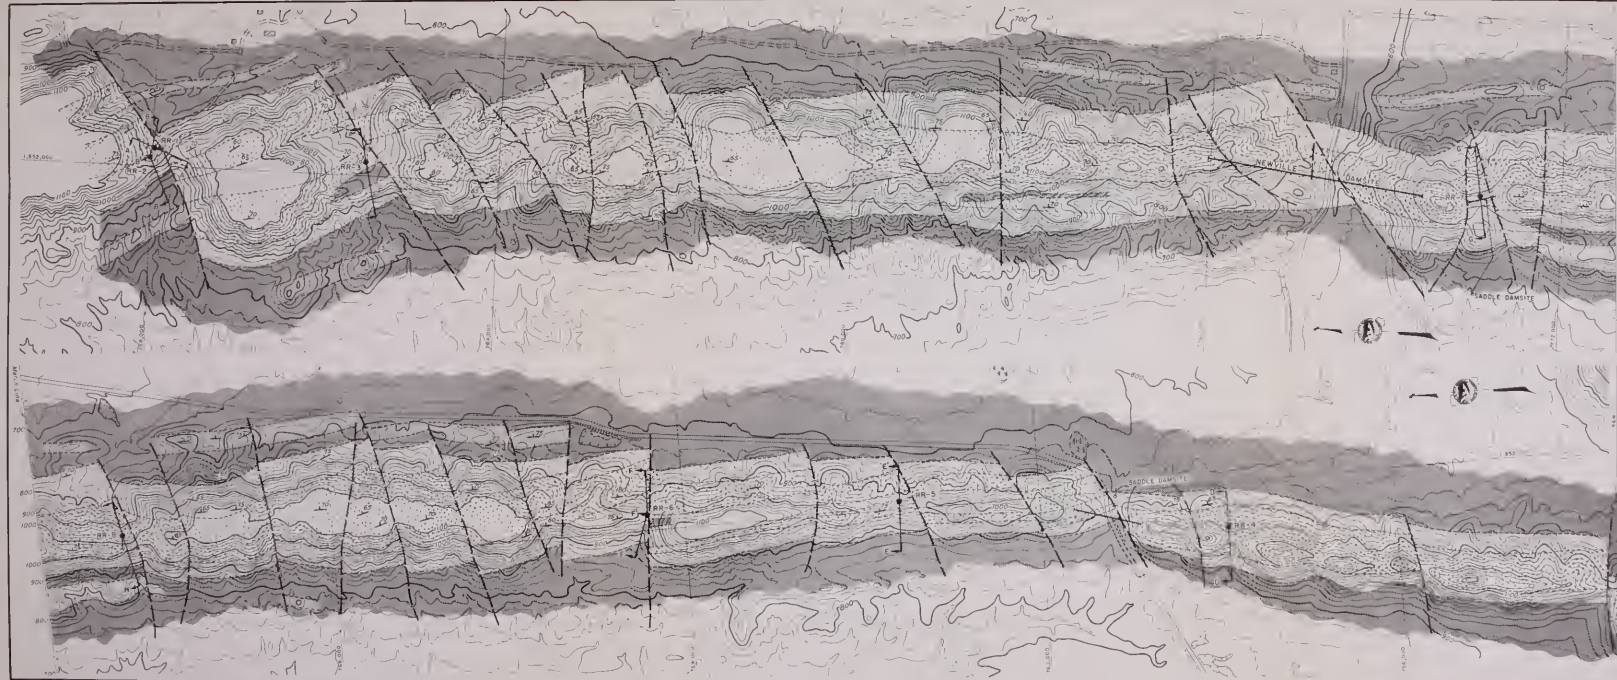
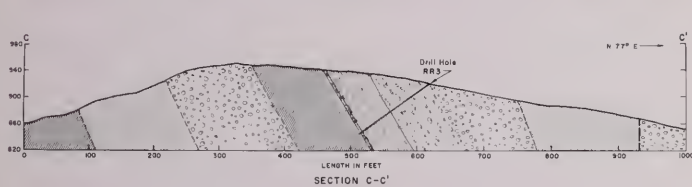
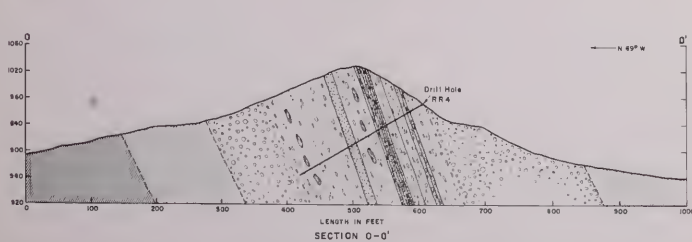
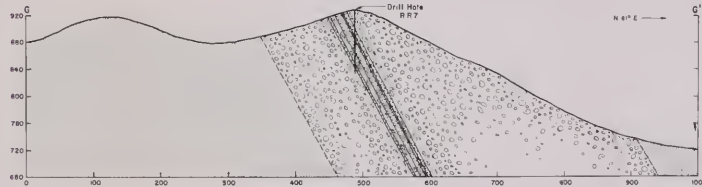
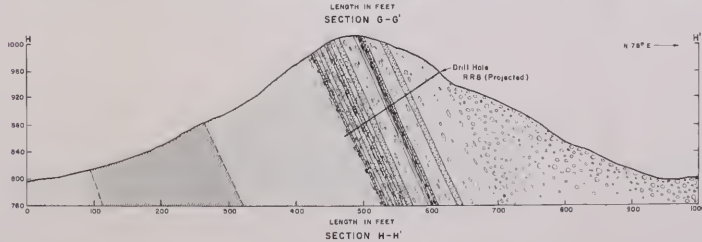
STATE OF CALIFORNIA
THE RESOURCES AGENCY
DEPARTMENT OF WATER RESOURCES
NORTHERN BRANCH
NORTH COASTAL AREA INVESTIGATION
GEOLOGIC SECTIONS
ROCKY RIDGE - EAST RIM OF
NEWVILLE RESERVOIR

NOTE: LOCATION OF SECTIONS APPEAR ON PLATE 16

- MUDSTONE - INVESTIGATED WITH DRILL HOLE
 MUDSTONE WITH OCCASIONAL SANDSTONE BEDS NOT MAPPED IN DETAIL
 SANDSTONE - INVESTIGATED WITH DRILL HOLE
 SANDSTONE WITH INTERBEDS OF CONGLOMERATE NOT MAPPED IN DETAIL
 CONGLOMERATE - INVESTIGATED WITH DRILL HOLE
 CONGLOMERATE WITH INTERBEDS OF SANDSTONE NOT MAPPED IN DETAIL
- GEOLOGIC CONTACT - DASHED WHERE APPROXIMATELY LOCATED
 FAULT - DASHED WHERE APPROXIMATELY LOCATED

broken down into units, based on the predominant rock type in each unit, and the contacts between these units were mapped. Most of the contacts are only approximately located as there was not enough time to walk out each contact, and the contacts are often covered by colluvium. Due to the lenticular nature of the beds, and the many thin beds, detailed geologic mapping of the ridge would be a very time-consuming task. (See the geologic crosssections through the drill holes, Plate 17.)

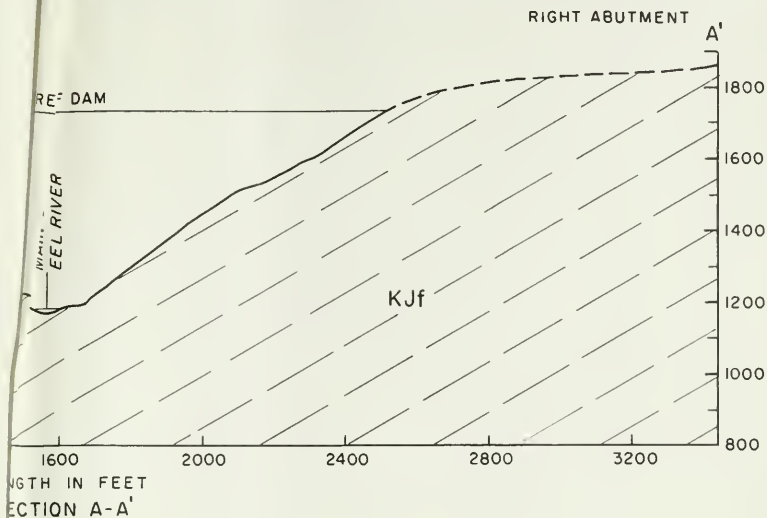
STATE OF CALIFORNIA
THE RESOURCES AGENCY
DEPARTMENT OF WATER RESOURCES
NORTHERN BRANCH
NORTH COASTAL AREA INVESTIGATION
GEOLOGIC MAP AND SECTION
ENGLISH RIDGE DAMSITE - EEL RIVER

COVERED BY A NEARLY CONTINUOUS MANTLE OF SLOPEWASH, RESIDUAL AVERAGE DEPTH OF 15 TO 20 FEET.

THE APPROXIMATE RATIO OF SANDSTONE TO SHALE IN THE DAM FOUND OUTCROPS ARE GOOD IN THE CHANNEL SECTION AND ARE SPOTTY

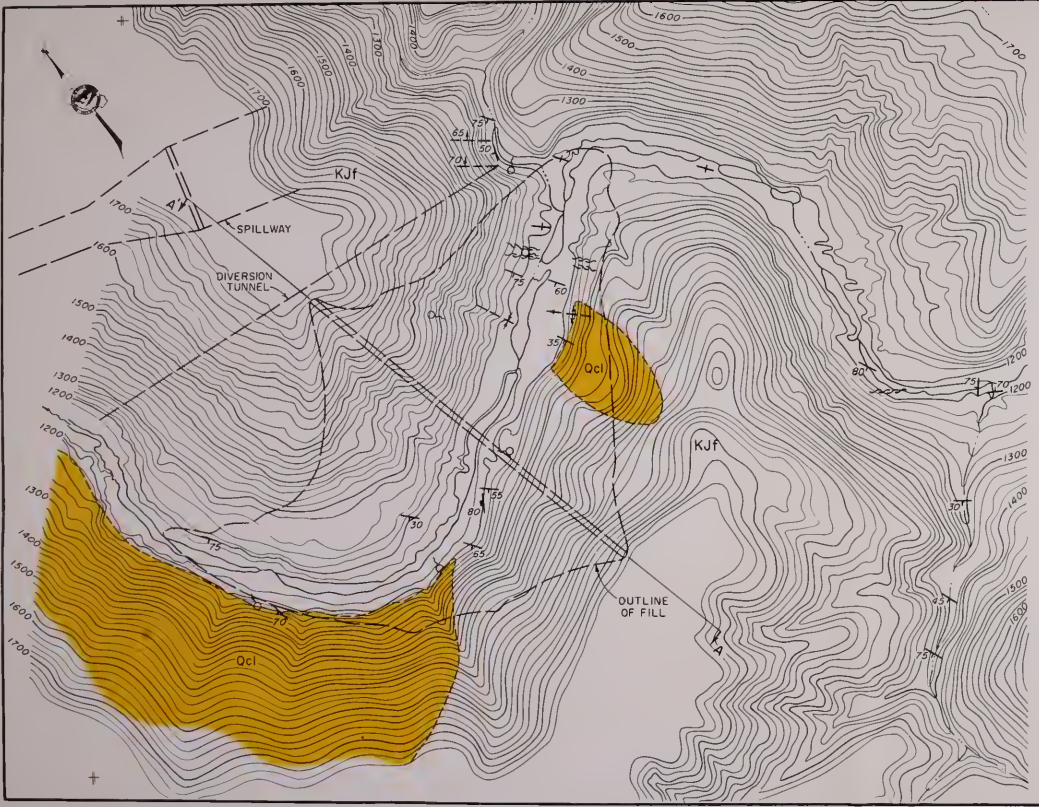
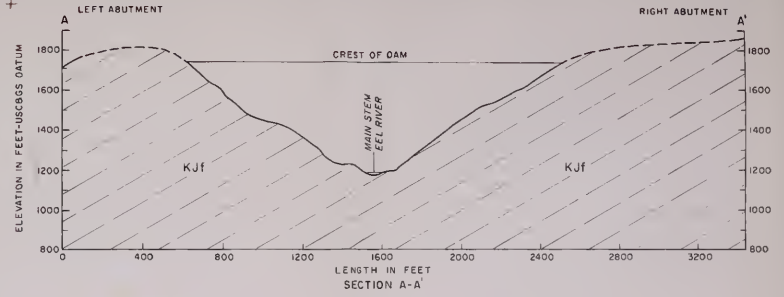
STATE OF CALIFORNIA
THE RESOURCES AGENCY
DEPARTMENT OF WATER RESOURCES
NORTHERN BRANCH
NORTH COASTAL AREA INVESTIGATION
GEOLOGIC MAP AND SECTION
ENGLISH RIDGE DAMSITE-EEL RIVER

QUATERNARY **Qcl** DEEP COLLUVIUM—AREAS OUTLINED ARE COVERED BY A NEARLY CONTINUOUS MANTLE OF SLOPEWASH, RESIDUAL SOIL AND LANDSLIDE DEBRIS TO AN AVERAGE DEPTH OF 15 TO 20 FEET.

KJf SANDSTONE WITH SHALE INTERBEDS—THE APPROXIMATE RATIO OF SANDSTONE TO SHALE IN THE DAM FOUNDATIONS WAS ESTIMATED AT 65% TO 35%. OUTCROPS ARE GOOD IN THE CHANNEL SECTION AND ARE SPOTTY ON THE ABUTMENTS.

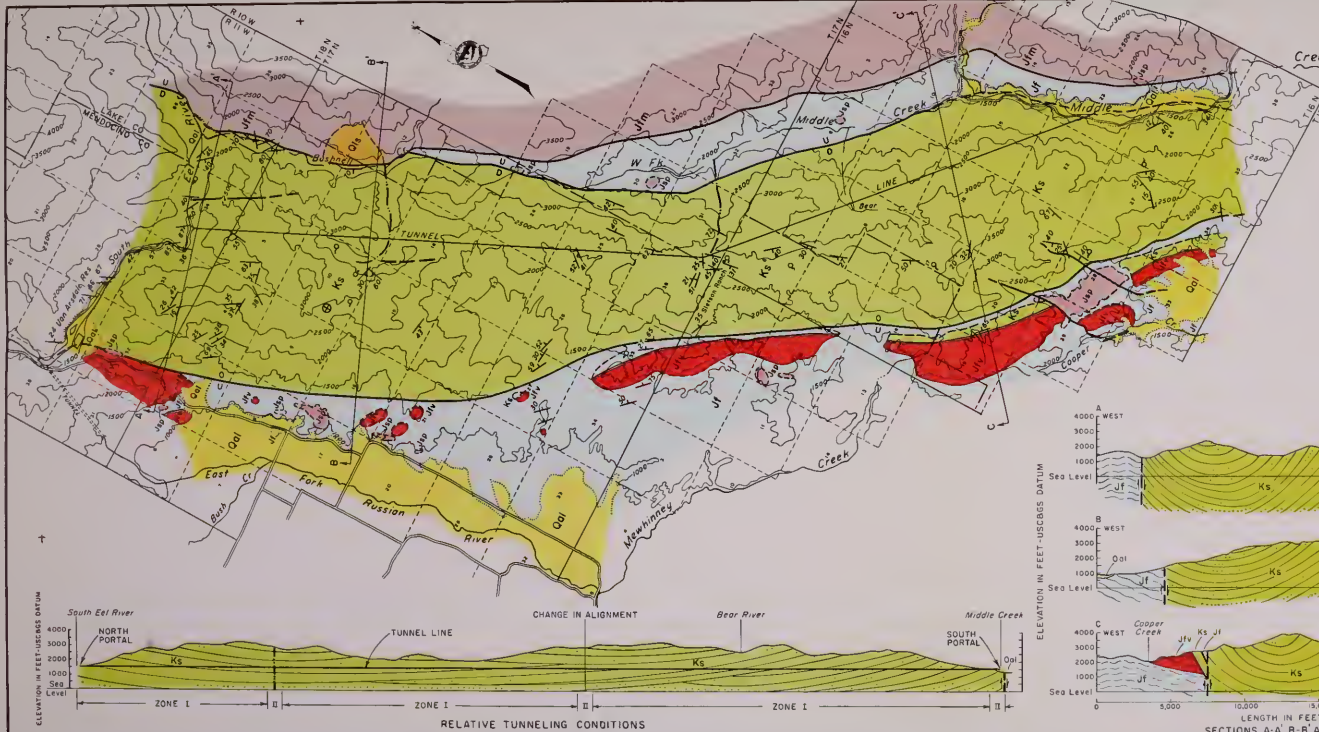
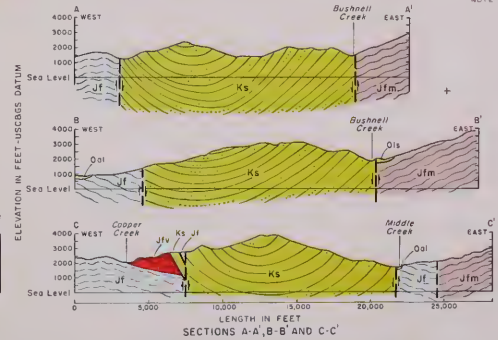
STATE OF CALIFORNIA
THE RESOURCES AGENCY
DEPARTMENT OF WATER RESOURCES
NORTHERN BRANCH
NORTH COASTAL AREA INVESTIGATION
GEOLOGIC MAP AND SECTIONS
GARRETT TUNNEL

- 30 STRIKE AND DIP OF BEDS
- ⊕ STRIKE OF VERTICAL BEDS
- ⊗ HORIZONTAL BEDS
- ⊙ SPRING AND SEEPS
- GEOLGIC CONTACT-DASHED WHERE INDEFINITE
- ALLUVIAL BOUNDARY
- U FAULT-SHOWING RELATIVE MOVEMENT
- ⊕ FAULT-CONCEALED
- WEAK ZONE-SHEARED AND FRACTURED ROCK
- A A' GEOLGIC SECTION LINE

NOTE REFER TO TEXT FOR A DETAILED DESCRIPTION OF RELATIVE TUNNELING CONDITIONS ZONES

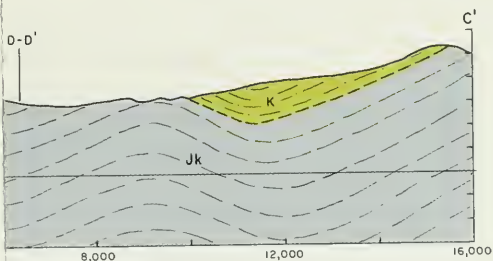
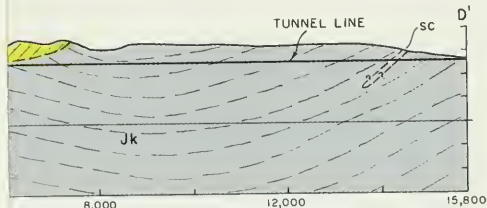
SECTION C-C'

SECTION D-D'

NE
E IS VARIABLE. IT OCCURS IN LENSES FREQUENTLY ELONGATED WITH THE
LL STRIKE. SERPENTINE MAY BE SHEARED ALONG FAULT CONTACTS, OR MAY
LE SHEARED BUT FRACTURED INTO IRREGULAR BLOCKS.

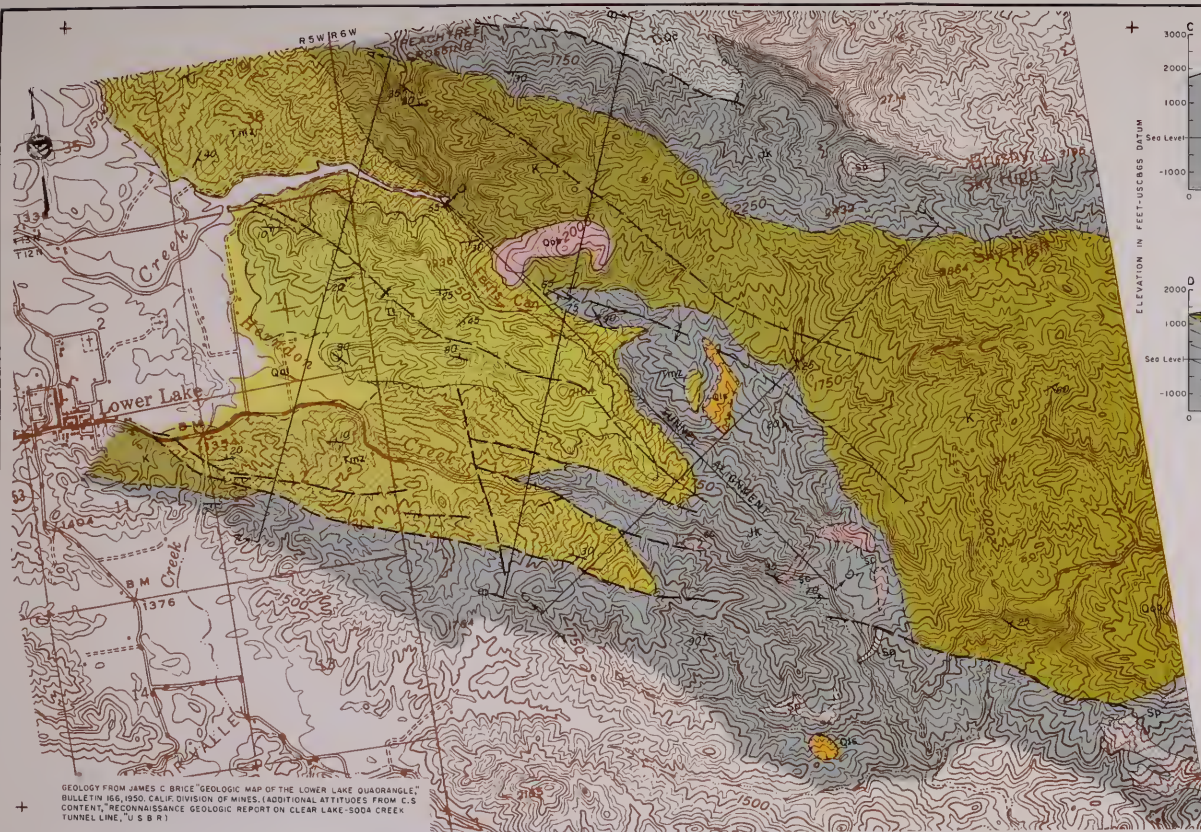
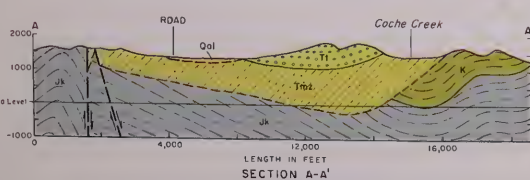
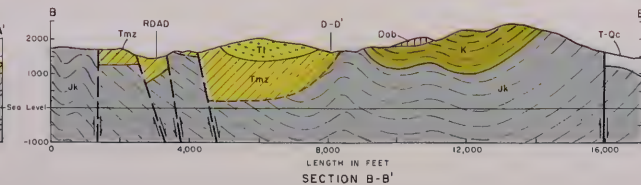
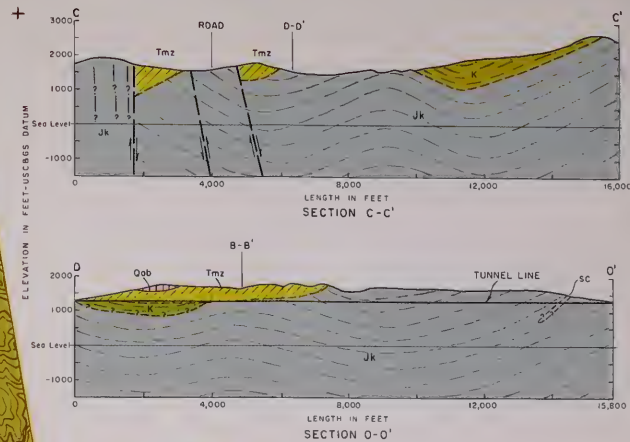
STATE OF CALIFORNIA
THE RESOURCES AGENCY
DEPARTMENT OF WATER RESOURCES
NORTHERN BRANCH
NORTH COASTAL AREA INVESTIGATION
**GEOLOGIC MAP AND SECTIONS
SODA CREEK TUNNEL**
SCALE OF FEET
2000 0 2000
Contour interval 20'

GEOLOGY FROM JAMES C. BRICE, "GEOLOGIC MAP OF THE LOWER LAKE QUADRANGLE," BULLETIN 166, 1950, CALIF. DIVISION OF MINES. (ADDITIONAL ATTITUDES FROM C.S. CONTENT), RECONNAISSANCE GEOLOGIC REPORT ON CLEAR LAKE-SODA CREEK TUNNEL LINE, U.S.G.M.R.1

- SC** SILICACARBONATE ROCK. SILICA MINERALS, FREQUENTLY OPAL, ASSOCIATED WITH CARBONATES OF THE CALCITE GROUP. MAY HAVE A VEINED OR SCHISTOSE STRUCTURE. IT IS COMMONLY FOUND IN ELONGATED MASSES IN FAULT ZONES AND NEAR SERPENTINE.

- Sp** SERPENTINE. TEXTURE IS VARIABLE. IT OCCURS IN LENSES FREQUENTLY ELONGATED WITH THE REGIONAL STRIKE. SERPENTINE MAY BE SHEARED ALONG FAULT CONTACTS, OR MAY BE LITTLE SHEARED BUT FRACTURED INTO IRREGULAR BLOCKS.

SECTION A-A' B-B' ARE FROM BRICE "STRUCTURE SECTIONS ACROSS LOWER LAKE QUADRANGLE" PLATE 7 OF CALIFORNIA DIVISION OF MINES BULLETIN 166.
